TECHNICAL INSPECTION REPORT

6 OPERATION CROSSROADS.
U.S.S. CRITTENDEN (APA 77)

TEST ABLE.

VOLUME 2 [U].

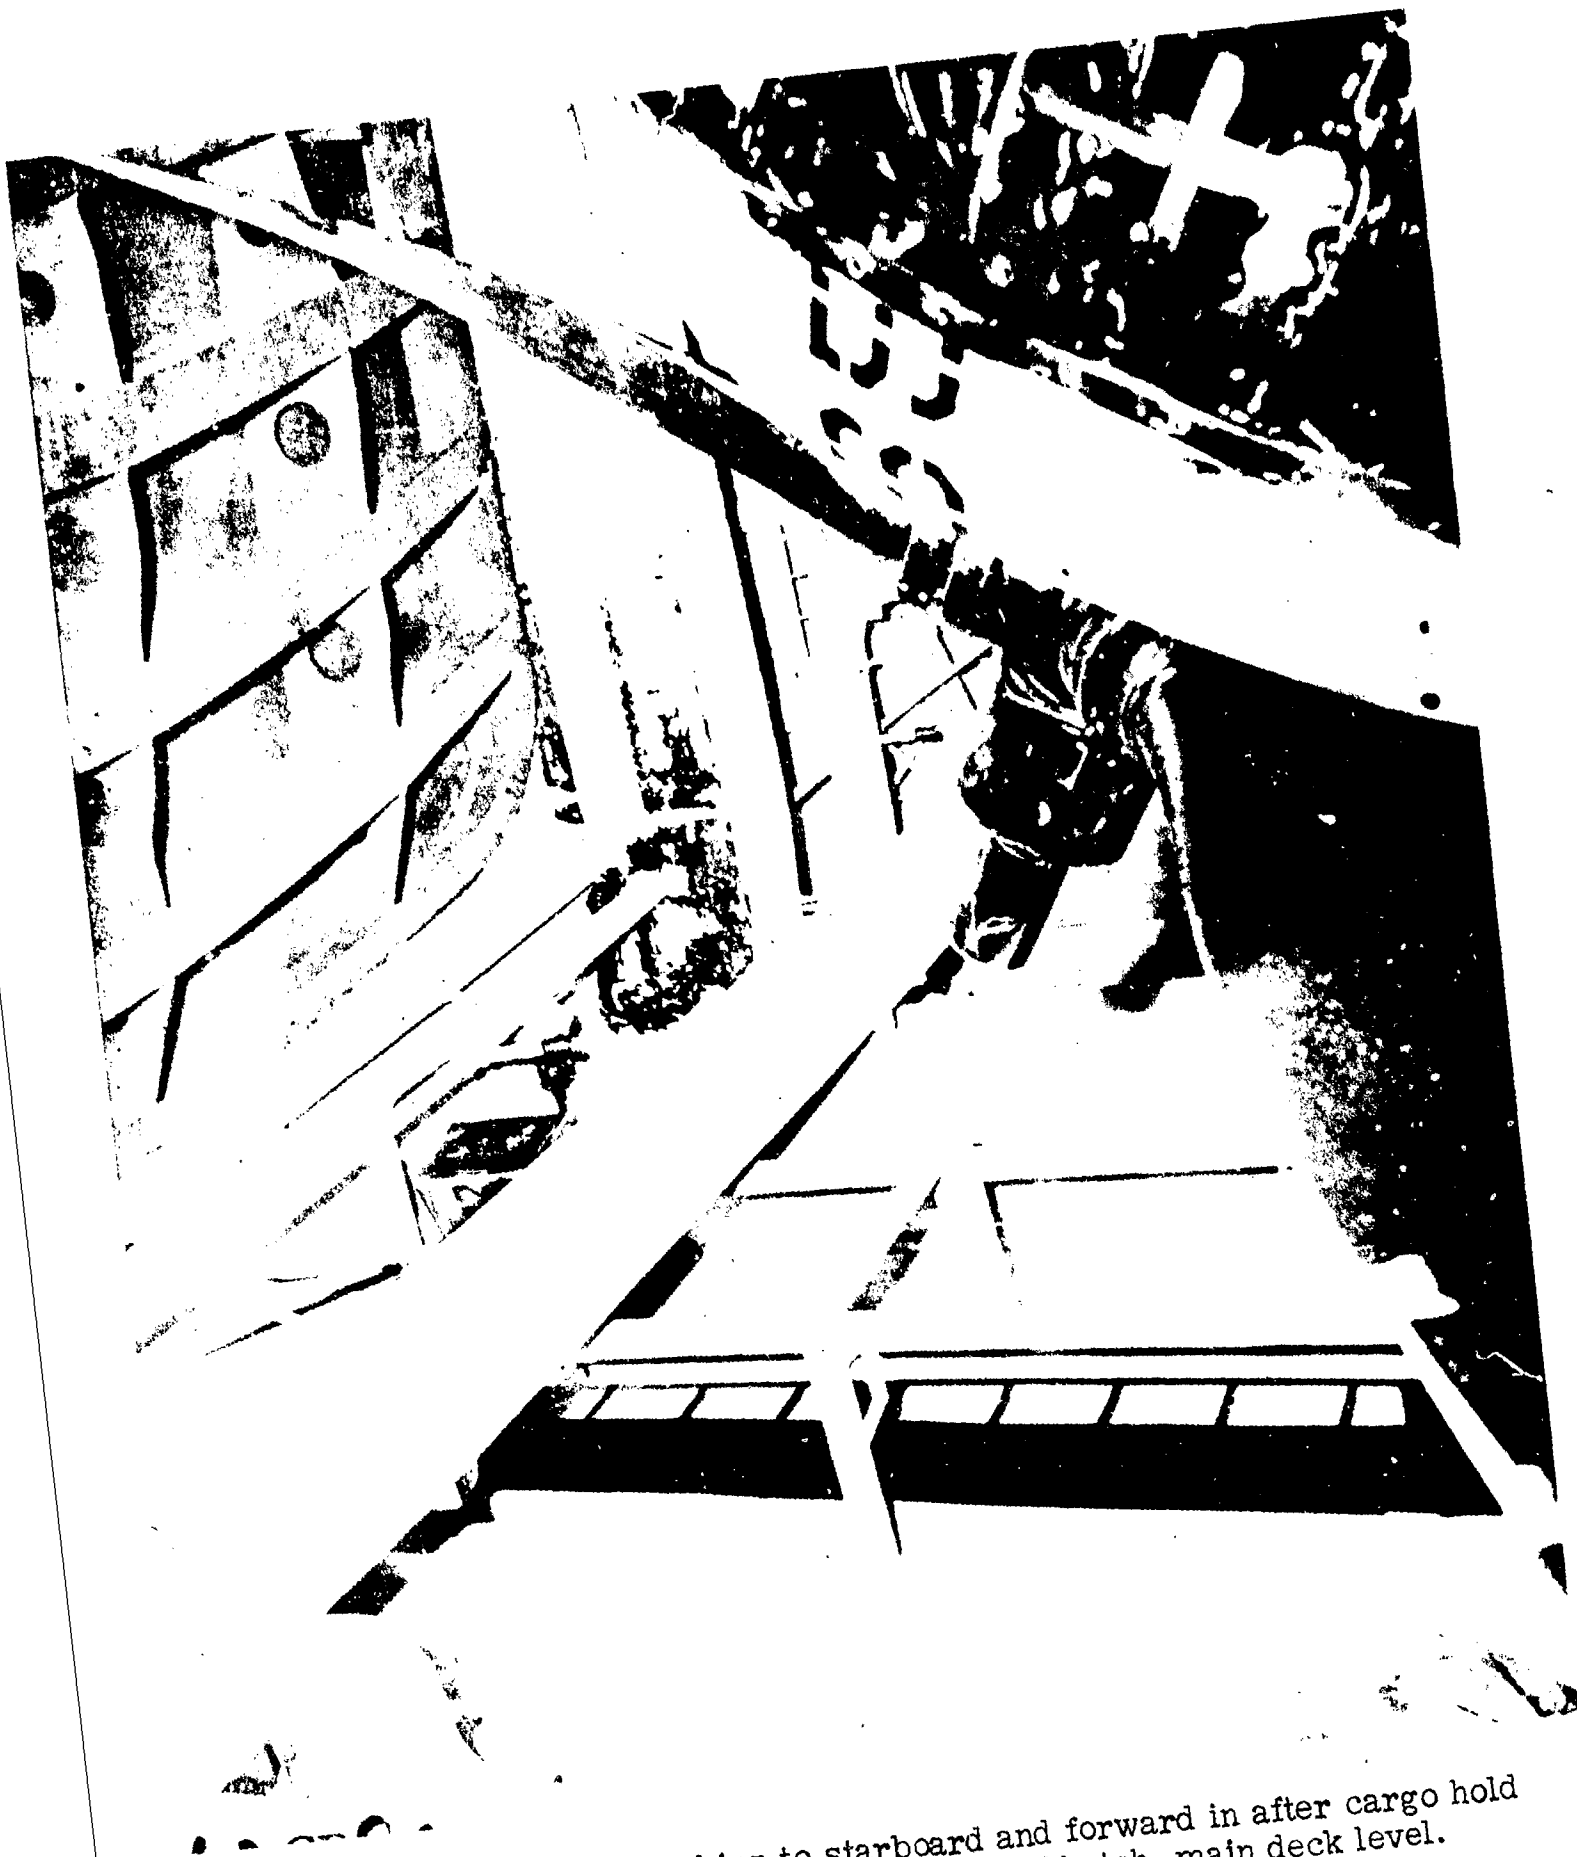
AA-CR-80-1908-7. Looking to starboard and forward in after cargo hold showing damaged girder at starboard edge of hatch, main deck level.

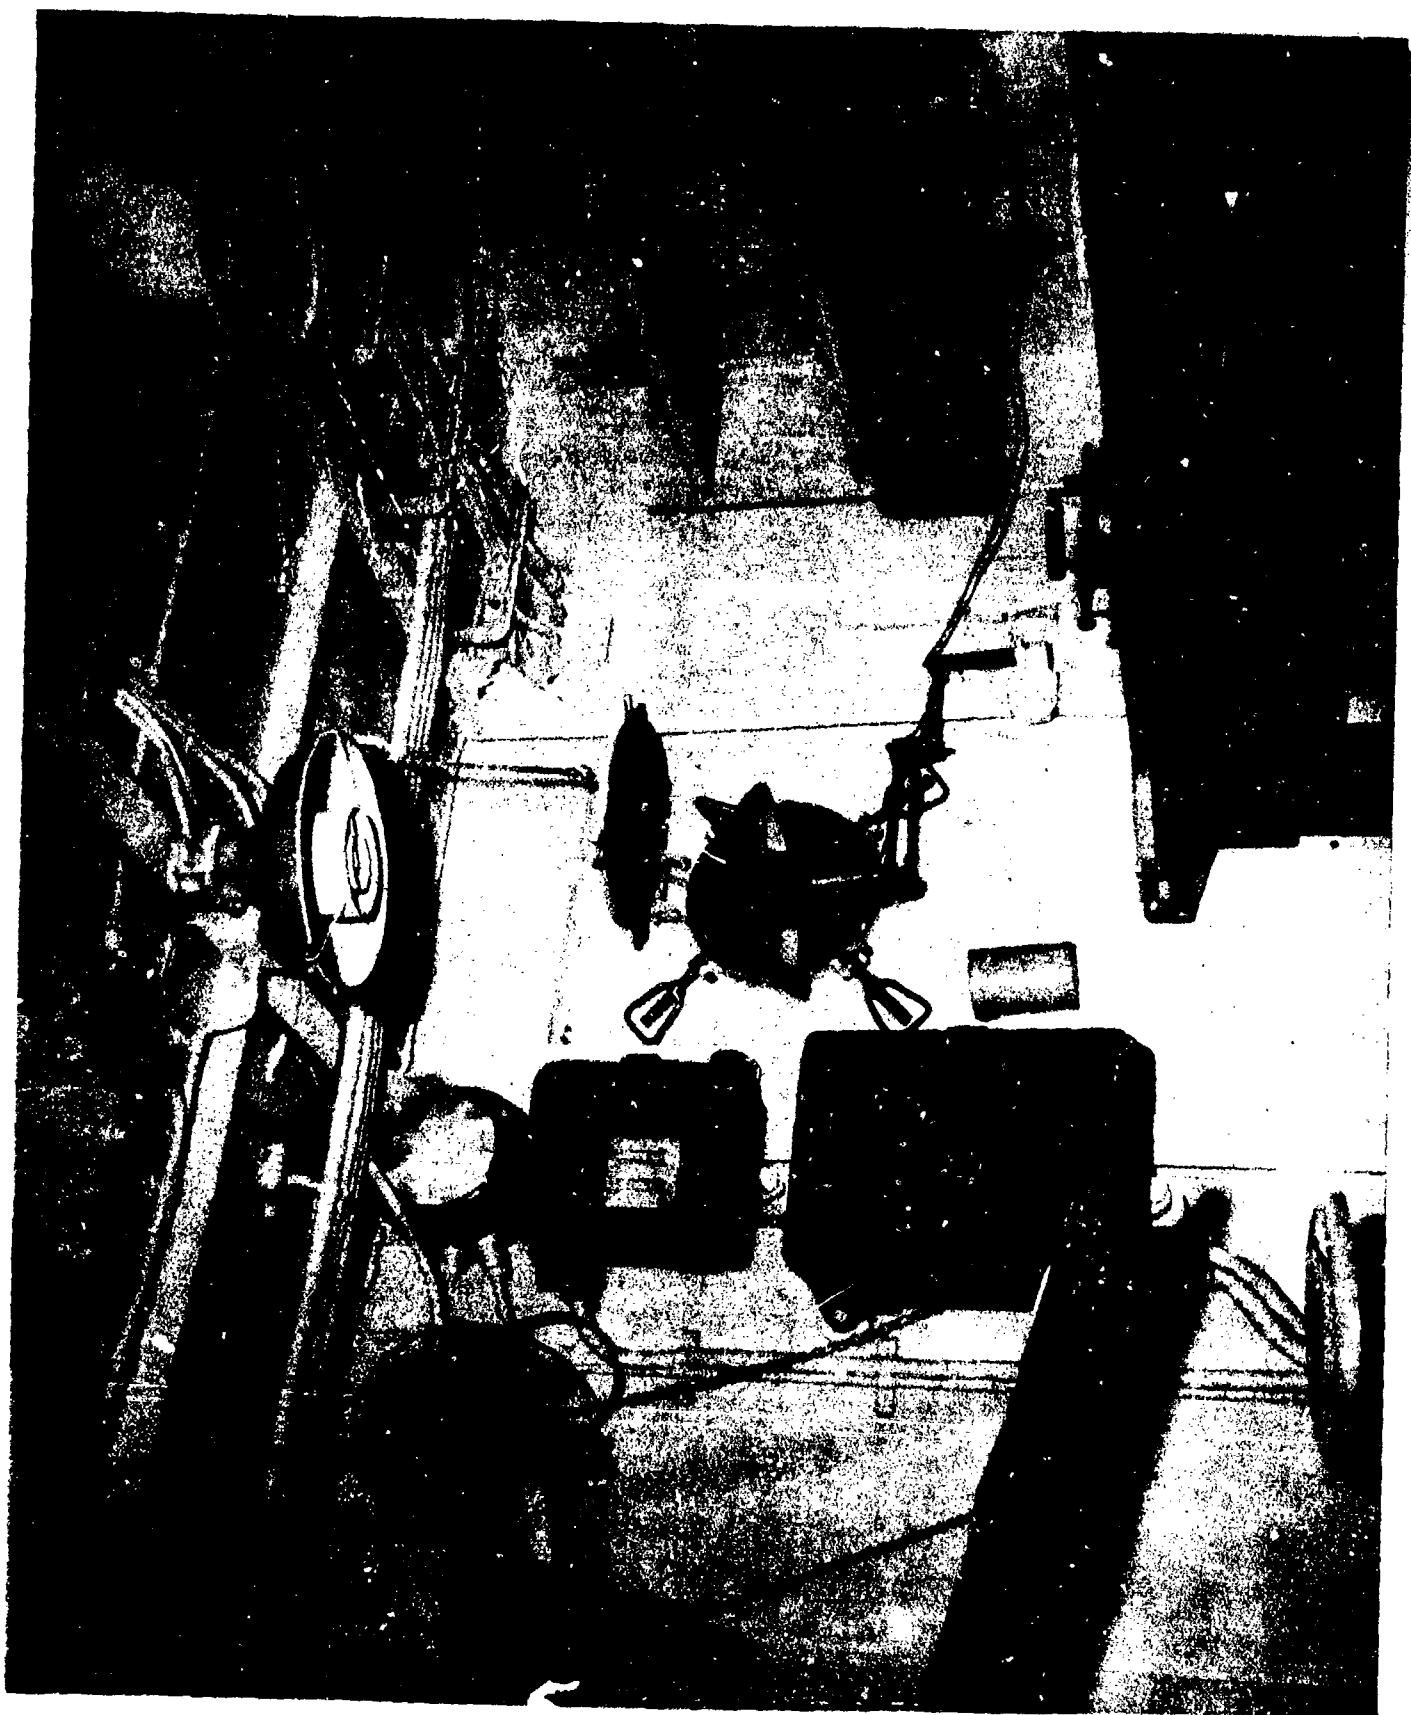
AA-CR-80-1905-5. Damage to port and forward bulkheads of chart room.

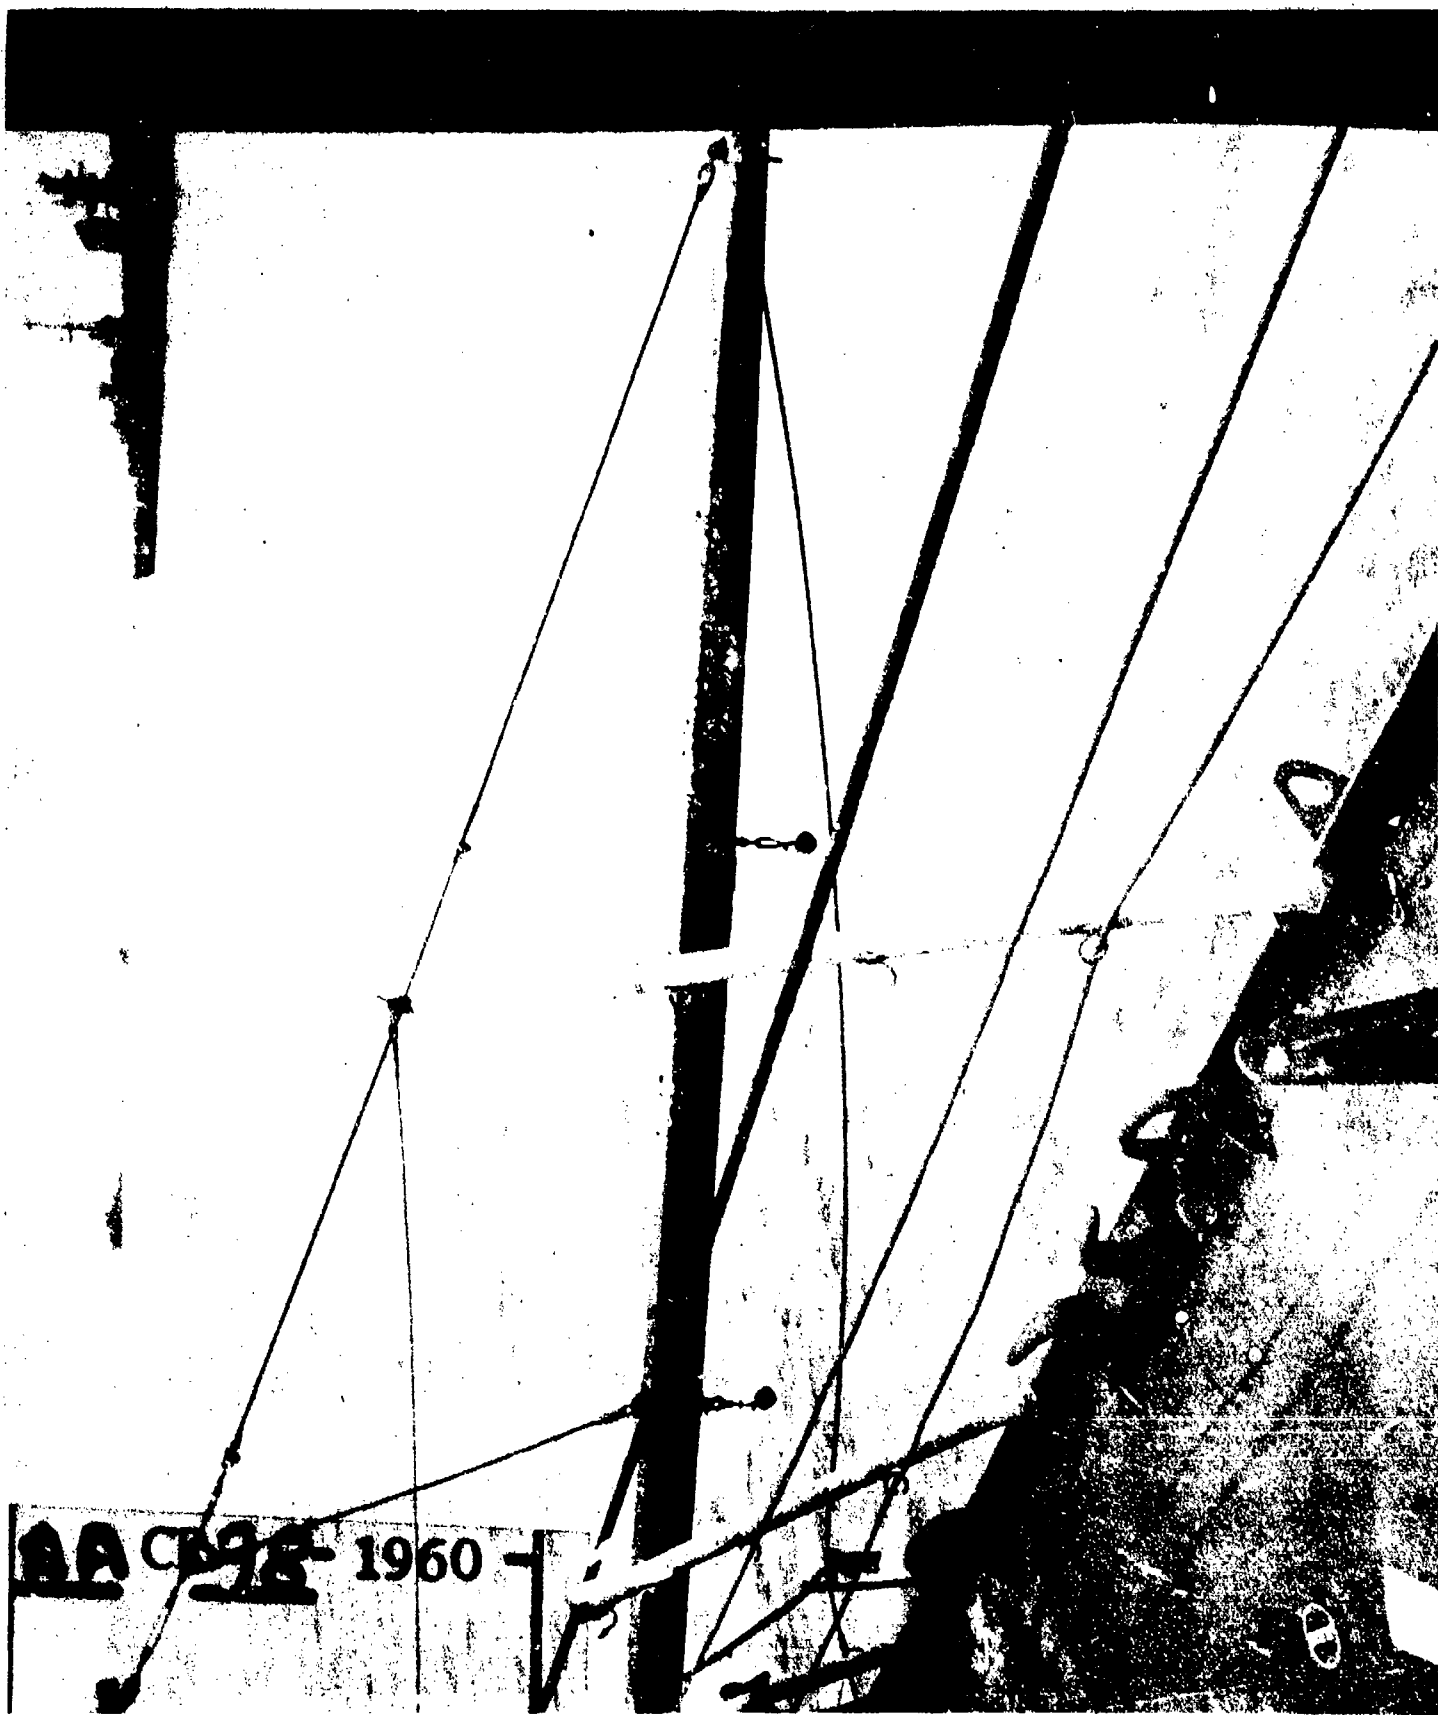
AA-CR-98-1960-12. Looking aft and to port showing burned paint on boat boom.
